Supplemental Environmental Assessment Document

East Micronesian Cable (EMC) Project

Marine Benthic Ecological Assessment Shallow Waters Associated with the Lelu Harbor cable alignment - Kosrae

December 2019

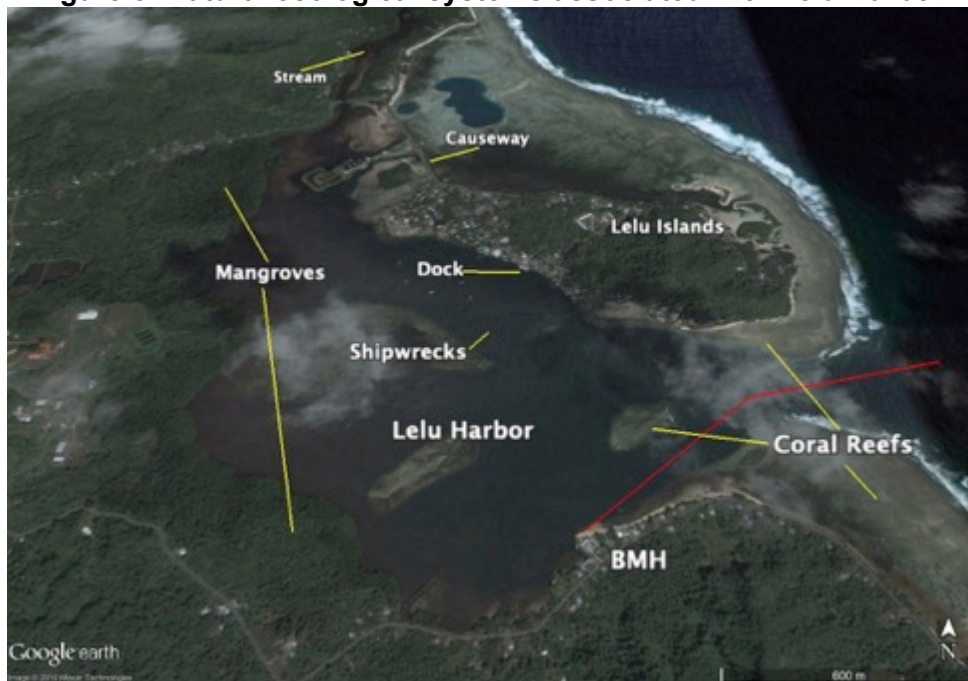
Figure 5: Natural ecological systems associated with Lelu Harbor.

Lelu Island and the harbor's northern and southern foreshore areas have undergone extensive reclamation and alteration over the past century resulting in significant alteration to the natural environment, although the mangrove forests to the west remain relatively intact. The construction of a causeway between the island of Lelu and the mainland shoreline on the northern side of the island in the 1960's has greatly reduced the natural water circulation patterns within the harbor and as a result sediment deposition within the harbor especially either side of the causeway has been significantly altered. This has had a significant negative effect on the natural marine and coastal ecosystem within the harbor (Figure 5).

Lelu harbor has extensive coral reef systems throughout the outer portion of the bay, which slowly decreases further into the harbor and is replaced with sand and mud/silt associated with the mangrove areas. The harbors benthic substrate is predominately composed of sand-mud in all areas outside of the reef systems. The harbor is tidally influenced with an average daily tidal height fluctuation of 1 m.

Lelu harbor has no marine protected areas although the small subtidal patch reef in the center of the harbor has been discussed as a potential marine managed – fisheries protected area (refer Figure 5), however is yet to be finalized and gazetted.

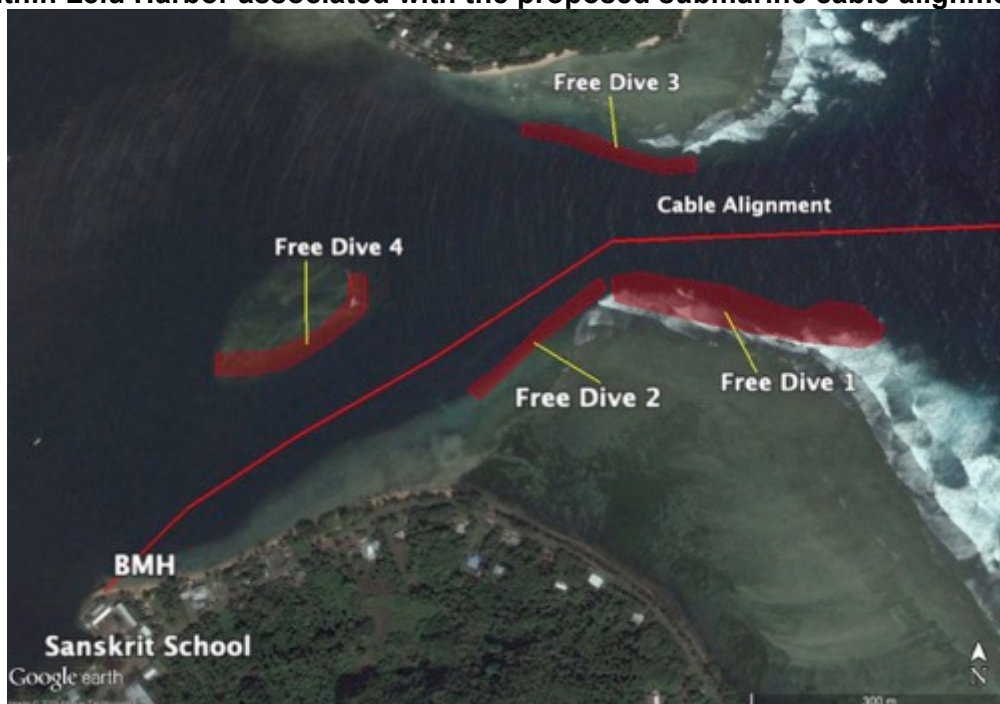
Figure 7: Location of the four Free Dive benthic marine assessment sites within Lelu Harbor associated with the proposed submarine cable alignment.

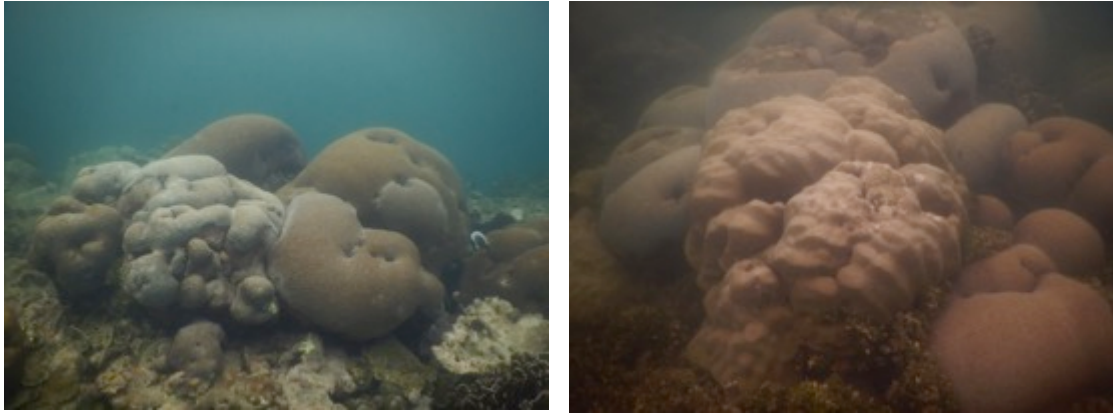
Figure 10: Examples of large massive hard corals located within FD site 1 and FD Site 2.

coral recruitment is occurring. A significant number of large massive coral heads (bommies) were recorded several in excess of 4-5 m circumference (Figure 10).

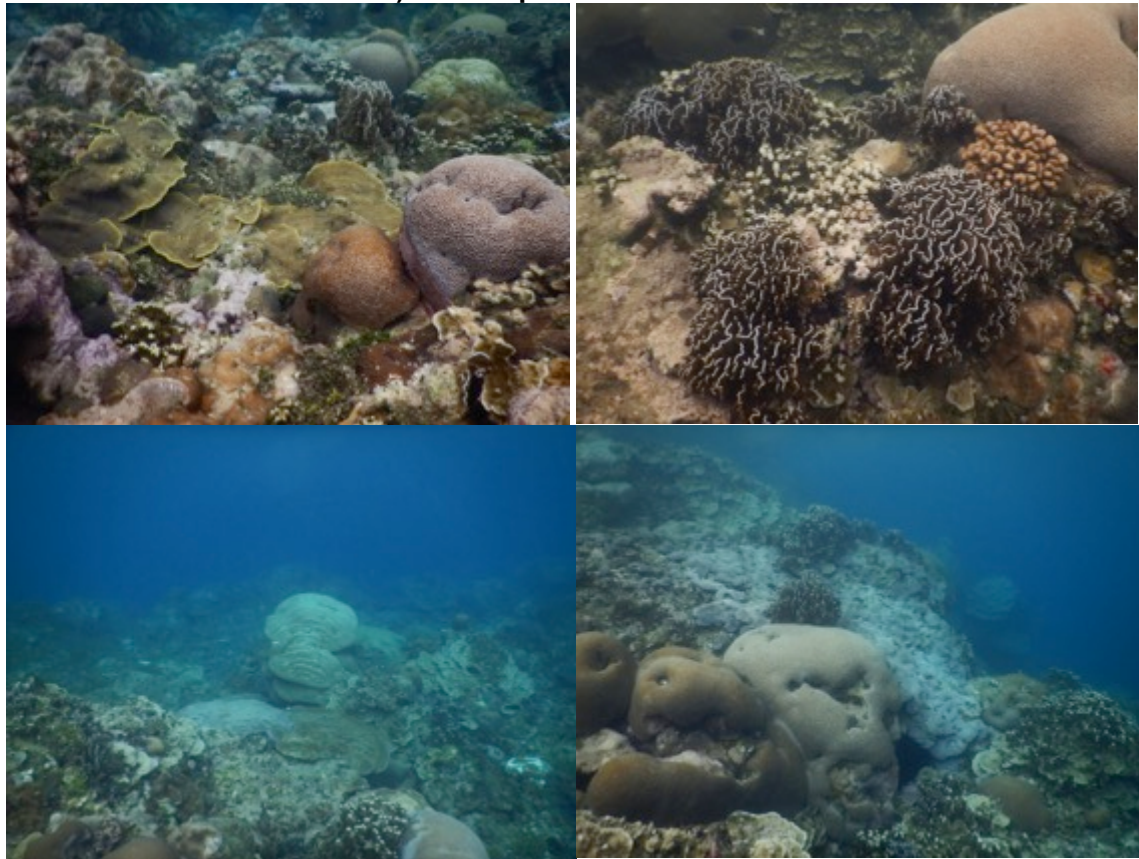
Hard coral live percentage coverage for the reef slope was considerably higher at FD Site 1 than FD Site 2. Live hard coral percent coverage associated with the upper reef slope (3-8 m water depth) ranged between 10 – 80 % for FD site 1 and 5 – 50% for FD Site 2, whilst hard coral percentage coverage for the lower reef slope (8- 20 m) ranged between 15-50% for FD Site 1 (Figure 12) and 5 – 35% for Free dive site 2 (refer Figure 13).

Figure 12: Hard coral live coverage for the subtidal upper (a & b) and lower (c & d) reef slope for FD Site 1.

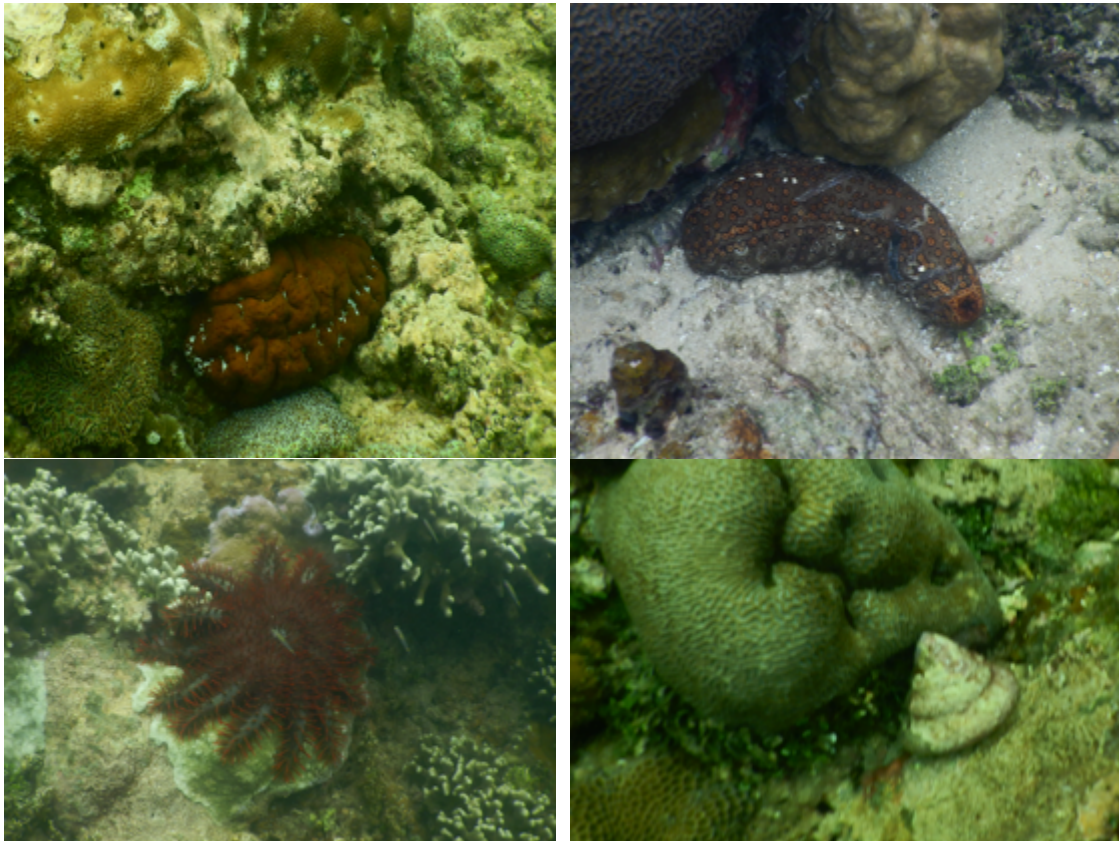
Figure 16: Echinoderms (a, b & c) and Mollusks (d) located during the marine assessments of FD Site 1 and 2.

The absence of predator finfish, the small size of individual finfish present and absence of subsistence and commercially valuable invertebrates indicates a high level of resource harvesting and/or an environment not conducive to support these resources. It is perceived that the former suggestion is currently operating within these reef areas.

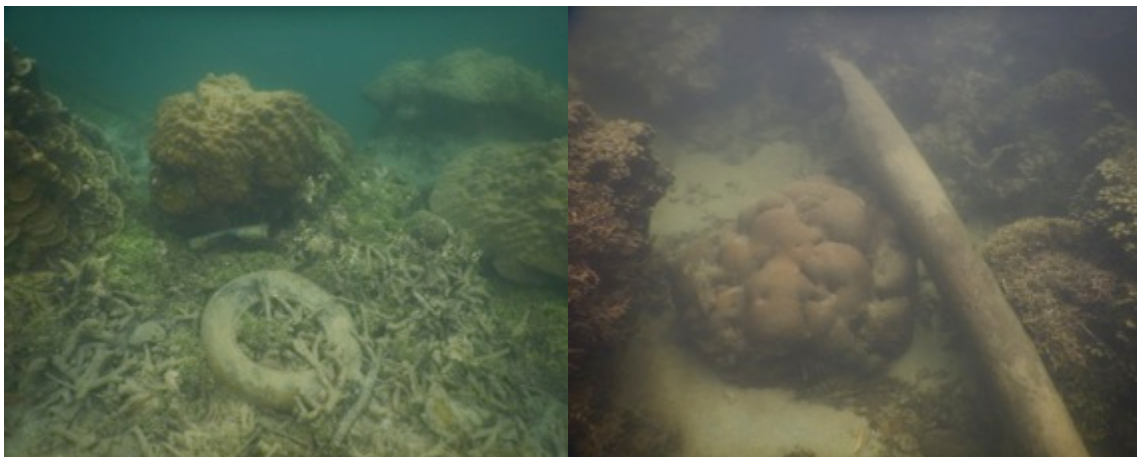
The marine benthic environment associated with the southern reef channel system entering the Lelu harbor contains anthropogenic rubbish and machinery (Figure 17) presumed to originate primarily from activities within and around Lelu harbor. FD Site 2 contained considerably more debris than FD site 1. A physical cleanup of this material in and around the channel and harbor is advisable to prevent further degradation of the marine environment.

Figure 17: Anthropogenic material and garbage located during the marine assessment at FD Site 2.

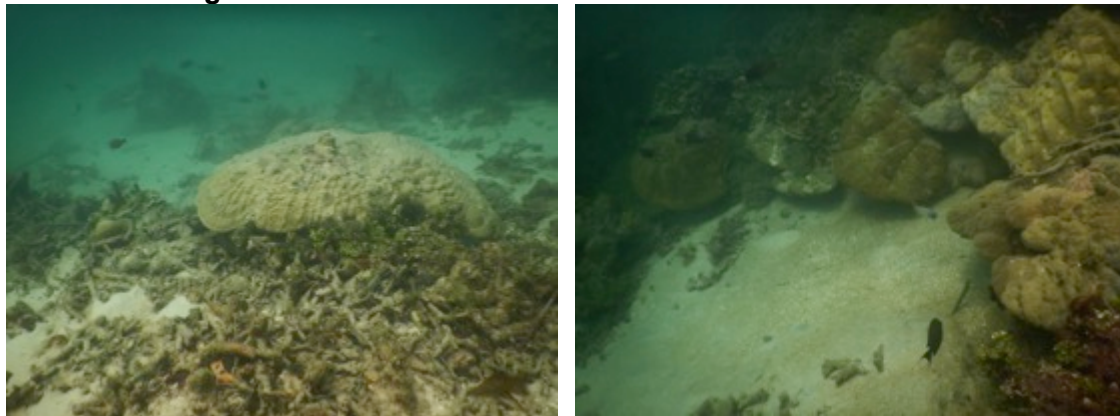
Figure 18: Seabed Substrate associated with FD Site 3.

The northern side of the Lelu channel was assessed in its entirety (FD Site 3) (refer Figure 7) and includes the subtidal reef area associated with the entire northern side of the Lelu channel. This assessment included a distinctive intertidal and subtidal fringing coral reef system characterised by a benthic substrate profile that is relatively homogenous throughout the surveyed area. The site possess an expansive intertidal reef flat (refer section 4.3 for full assessment description) that is exposed during low spring tides, a small relative flat subtidal reef flat (5-8 m in width), a distinctive however small reef crest and reef edge (4-6 m in width), a short upper reef slope (4-6 m width) that descends (30-50 degree) into the lower reef slope that continues relatively steeply (40-70 degree) and terminates directly onto a sand/slit/coral rubble dominated benthic substrate sea floor. Coral rubble and small coral fragments are located throughout the reef system and directly below the living coral on the lower reef slope, however due to high levels of sedimentation associated with these sites it is envisaged that larger coral fragments deposited onto the sea floor during inclement weather conditions are covered (Figure 18). The subtidal reef system varies in depth west to east and ranges between 6 m towards the western side of the channel through to 10 m within the channel.

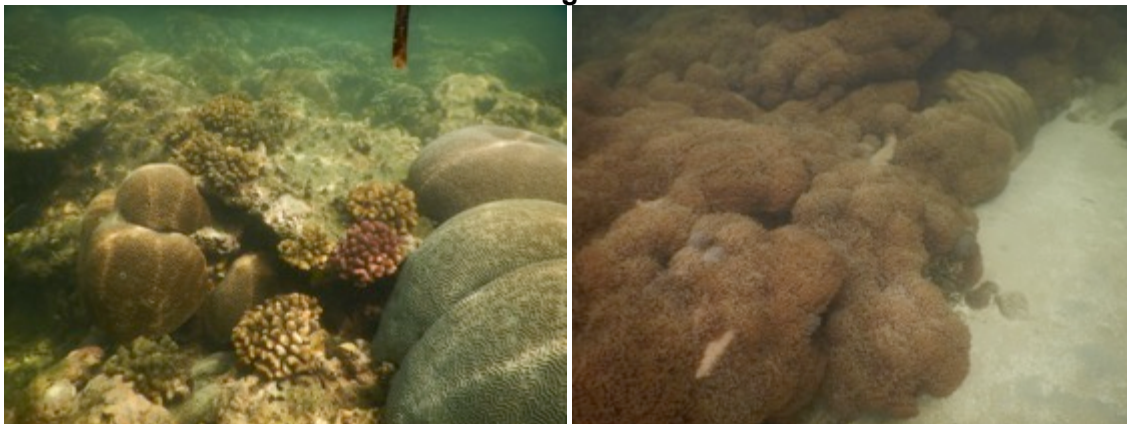
Figure 20: Hard coral colony examples located within the within the subtidal reef crest and edges of FD Site 3.

Live hard coral percent coverage associated with the inshore subtidal reef areas (reef crest and edge) for FD Site 3 ranged between 0 - 25%. Hard coral percentage coverage within these reef zones was similar throughout the assessment site and included hard coral massive, digitate and encrusting morphological forms (Figure 20).

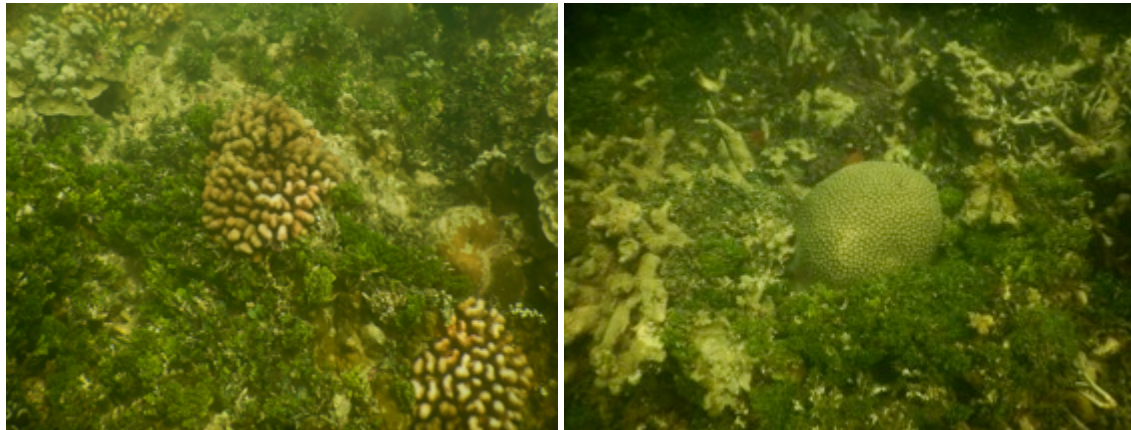
Figure 23: Examples of marine macro algae located within the shallow reef areas associated with FD Site 3.

Marine macro algae were located throughout the assessment site predominately within the shallow marine waters associated with the outer sections of the subtidal reef flat, reef crest, reef edge and upper reef slope. Macro algal population densities and species assemblages included a number of brown algae (*Sargassum sp.*, *Padina sp.*), substantial colonies of calcium carbonate green colonies (*Halimeda sp.*), filamentous green and blue green algae (Figure 23), whilst encrusting coralline algae were recorded only in the eastern end of the FD site. Higher population densities of coralline algae were recorded towards the wave action reefs to the north east of the assessment site. No sea grass or mangroves were located within this assessment site.

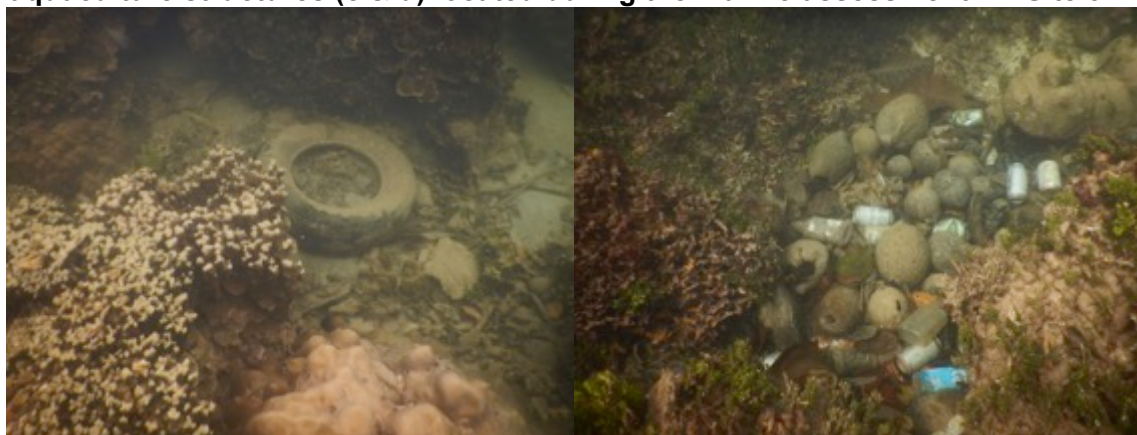
The marine benthic environment associated with the northern reef channel system entering the Lelu harbor contains anthropogenic rubbish (Figure 25 a & b) and decommissioned (abandoned) steel (re-bar) aquaculture structure's located within the upper reef slope (Figure 23 c & d) presumed to originate primarily from activities within and around Lelu harbor and past hard coral and clam growout nursery phases, respectively. A physical cleanup of the abandoned aquaculture structure should be undertaken taking care to remove and reposition the coral growing on these structures.

Figure 25: Anthropogenic material, rubbish (a & b) and decommissioned aquaculture structures (c & d) located during the marine assessment FD Site 3.

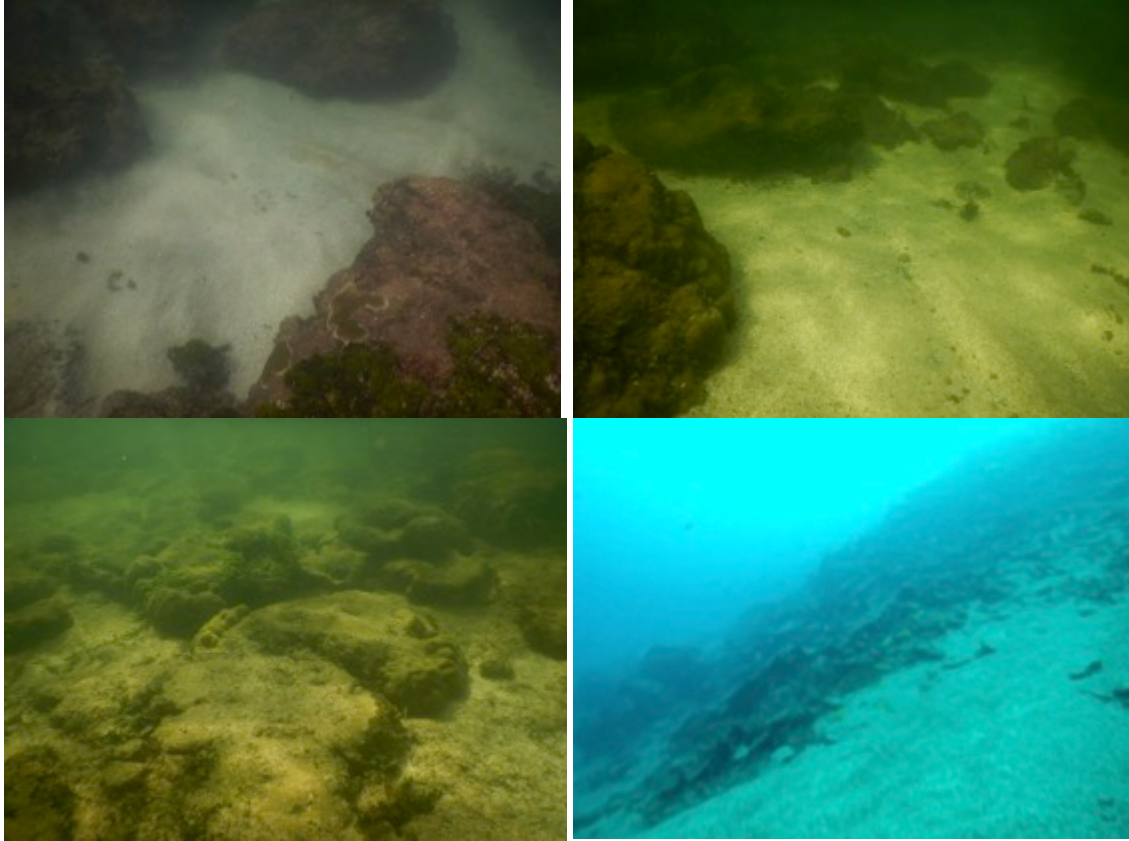
Figure 26: Seabed Substrate associated with FD Site 4.

The subtidal patch reef located directly west of the Lelu channel within the middle of the Lelu harbor (FD Site 4) (refer Figure 7) was assessed along its northeastern corner (open to the channel) and along the southern side of reef system. The assessment included a distinctive intertidal and subtidal patch coral reef system characterised by a benthic substrate profile that is relatively homogenous throughout the surveyed area. The site possess an intertidal and subtidal reef flat that is exposed partially during low spring tides located across the entire top of the patch reef, a distinctive however very small reef crest and reef edge (2-5 m in width) which in sections is difficult to identify, a short upper reef slope (5-8 m width) that descends (20-40 degree) into the lower reef slope (5-10 m width) that continues relatively steeply (40-70 degree) and terminates directly onto a sand/slit/coral rubble dominated benthic substrate sea floor. Coral sand, rubble and small to medium size coral fragments are located throughout all reef areas assessed and completely dominates all benthic habitats directly below the living coral on the lower reef slope (Figure 26). Higher levels of mud/silt (sediment derived from terrigenous origins) within the benthic substrate were located throughout the site when compared the FD Site 1 and 2, which reflects the water circulation patterns within Lelu harbor and their direct affect on this reef system. The subtidal reef system varies in depth west to east and ranges between 6 m towards the south western side of the patch reef channel through to 10-12 m on the north western end towards the channel.

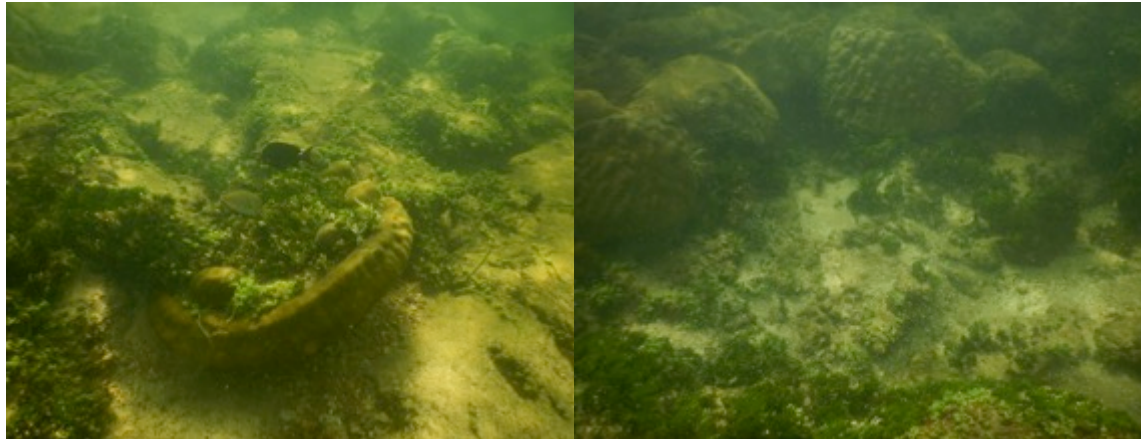
Figure 27: Hard coral colony examples located within the intertidal and subtidal reef flat of FD Site 4.

Live hard coral percent coverage associated with the intertidal and subtidal reef flat (the top of the patch reef) for FD Site 4 ranged between 0 - 10%. Hard coral percentage coverage within these reef zones was similar throughout the assessment site and included almost exclusively sub massive hard coral massive morphological forms, predominately *Porities sp.* (Figure 27).

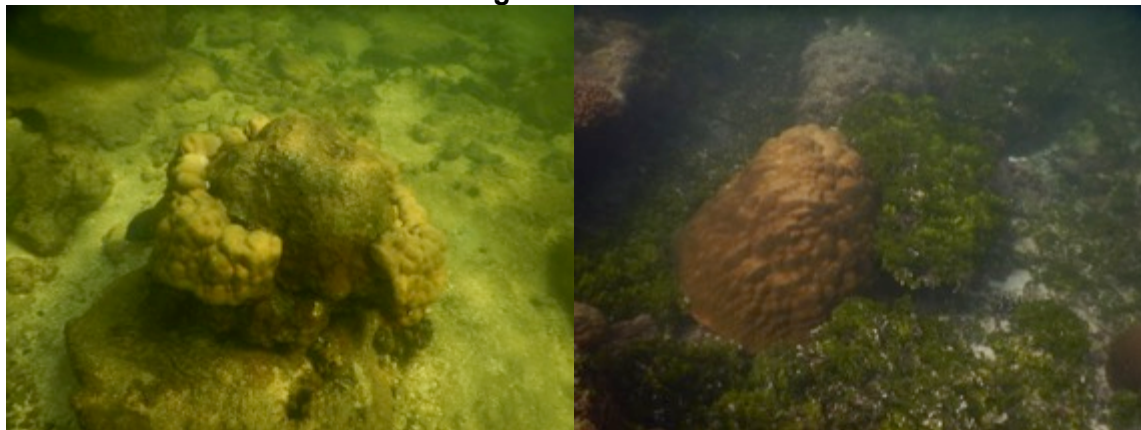
Figure 28: Hard coral colony examples located within the subtidal reef crest and edges of FD Site 4.

Live hard coral percent coverage associated with the subtidal reef areas (reef crest and edge) for FD Site 4 ranged between 0 - 15%. Hard coral percentage coverage within these reef zones was similar throughout the assessment site (Figure 28).

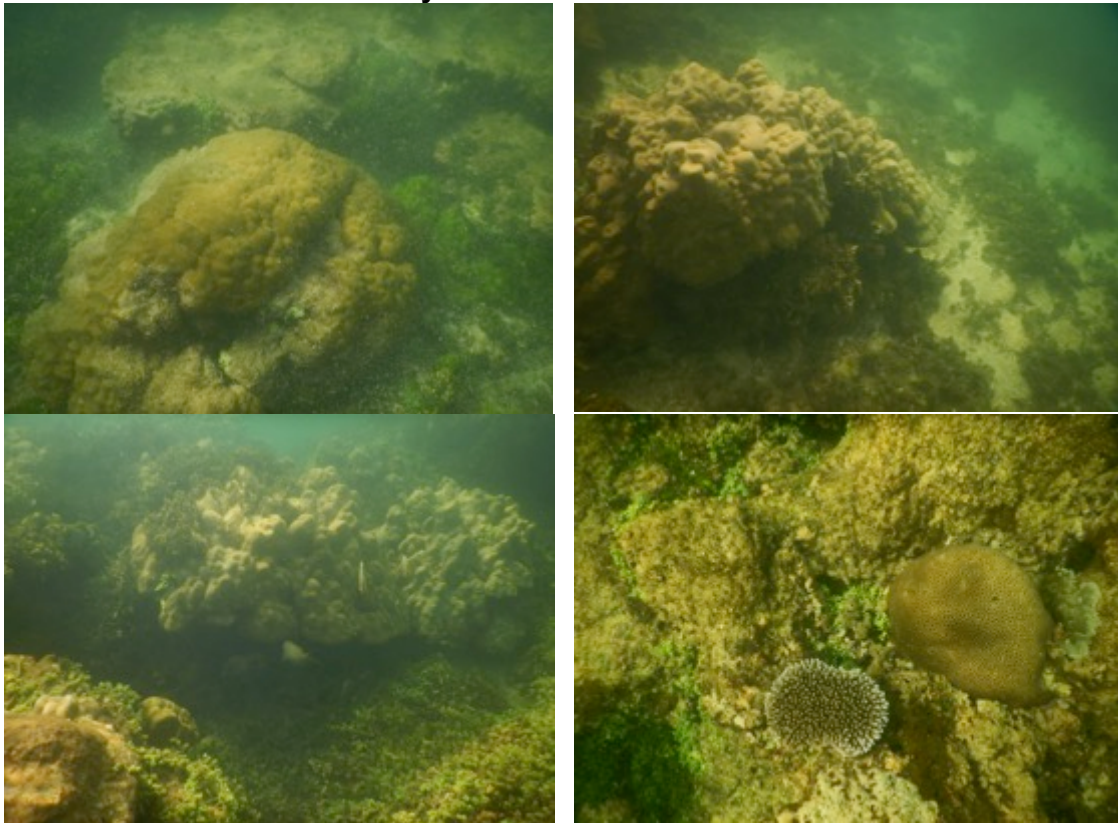
Figure 29: Hard coral colony examples located within the subtidal reef slope systems for FD Site 4.

Hard coral live percentage coverage associated with the upper reef slope (3-4 m water depth) and lower reef slope were similar and ranged between 5 – 25 % for FD Site 4. Hard coral sub massive and massive morphological forms dominated the assessment areas, however small colonies of hard coral branching, digitate and encrusting forms were recorded (Figure 29).

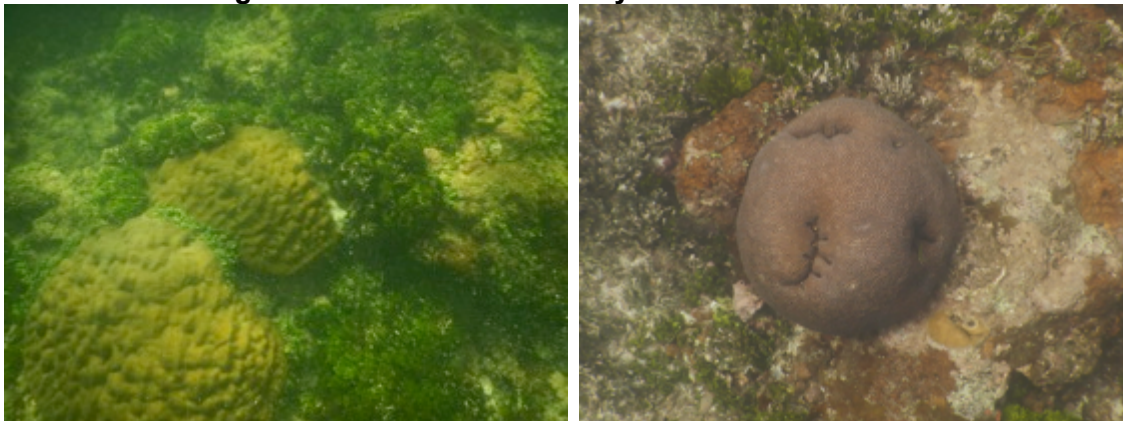
Figure 30: Hard coral diversity located at FD Site 4.

Hard coral morphological forms (size, structure) throughout FD Sites 4 were relatively homogenous and reflect the ecosystem parameters within the area. Hard coral species diversity and morphology remained similar in each of the reef zones. Hard coral sub massive and massive (e.g. *Porities sp.*, *Favites sp.*, *Monitipora sp.*, *Lobophyllia sp.*, *Goniopora sp.*) forms dominated all reef areas assessed. Their dominance is a direct result of the environmental parameters associated with this site. Limited numbers of hard coral digitate (e.g. *Acropora sp.*, *Pocillopora sp.*, *Porities sp.*), branching (e.g. *Acropora sp.*, *Pocillopora sp.*, *Millepora sp.*) and solitary (e.g. *Fungia sp.* and *Heliopungia sp.*) morphological forms were located throughout the assessment site (Figure 30).

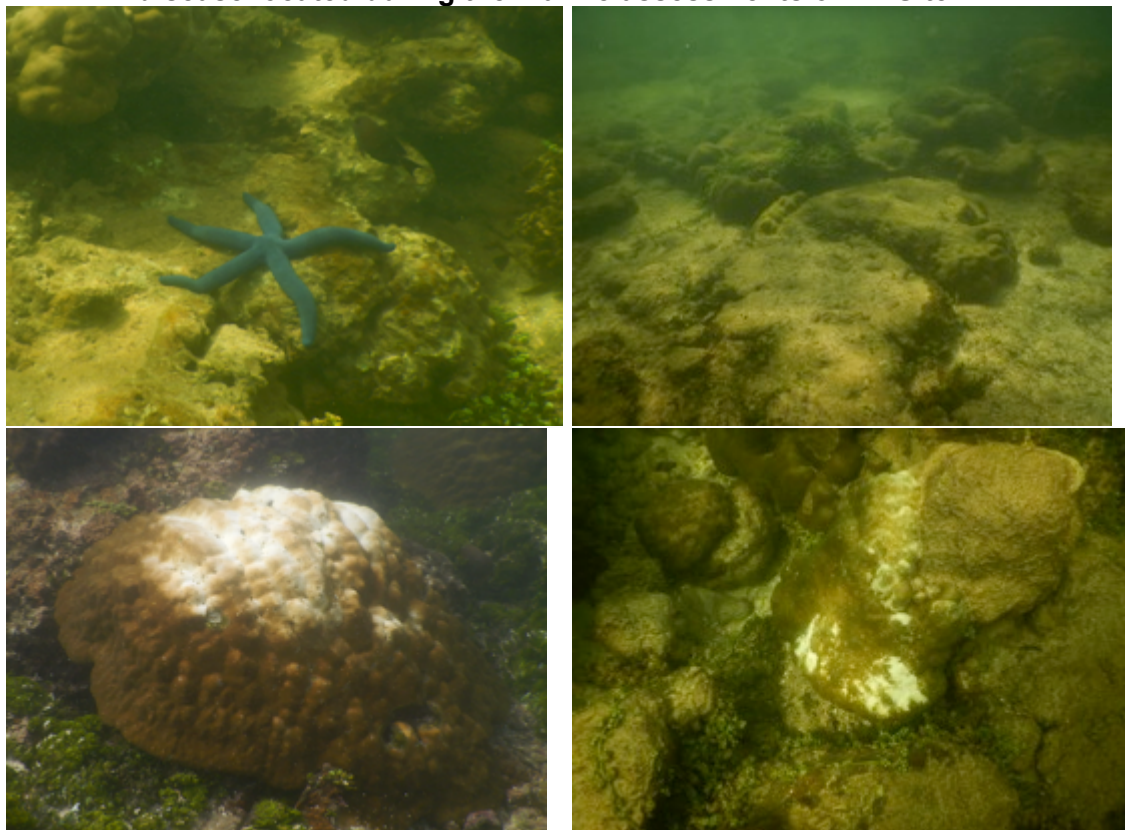
Evidence was located throughout FD Site 4 of hard coral mortality (recent and past events) (Figure 32 b) predominantly associated with sub massive forms resulting from environmental conditions (siltation - smothering) and recent death of section of coral heads (Figure 32 c and d). There was no direct evidence of the cause of this mortality recorded.

Figure 32: Starfish (a), hard coral mortality (b) and hard coral damage or disease located during the marine assessments of FD Site 4.

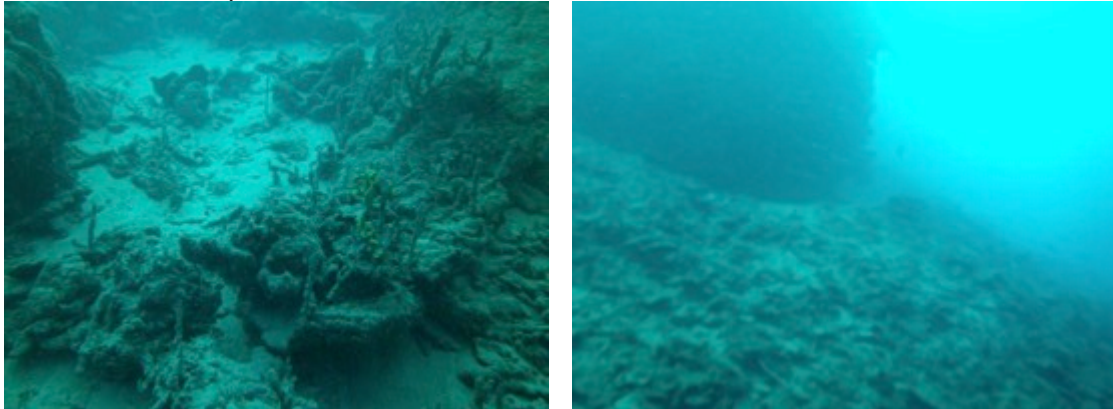
Figure 35: Representative benthic coral rubble and reef fragments associated with the lower reef slope and seabed interface within Lelu harbor and channel.

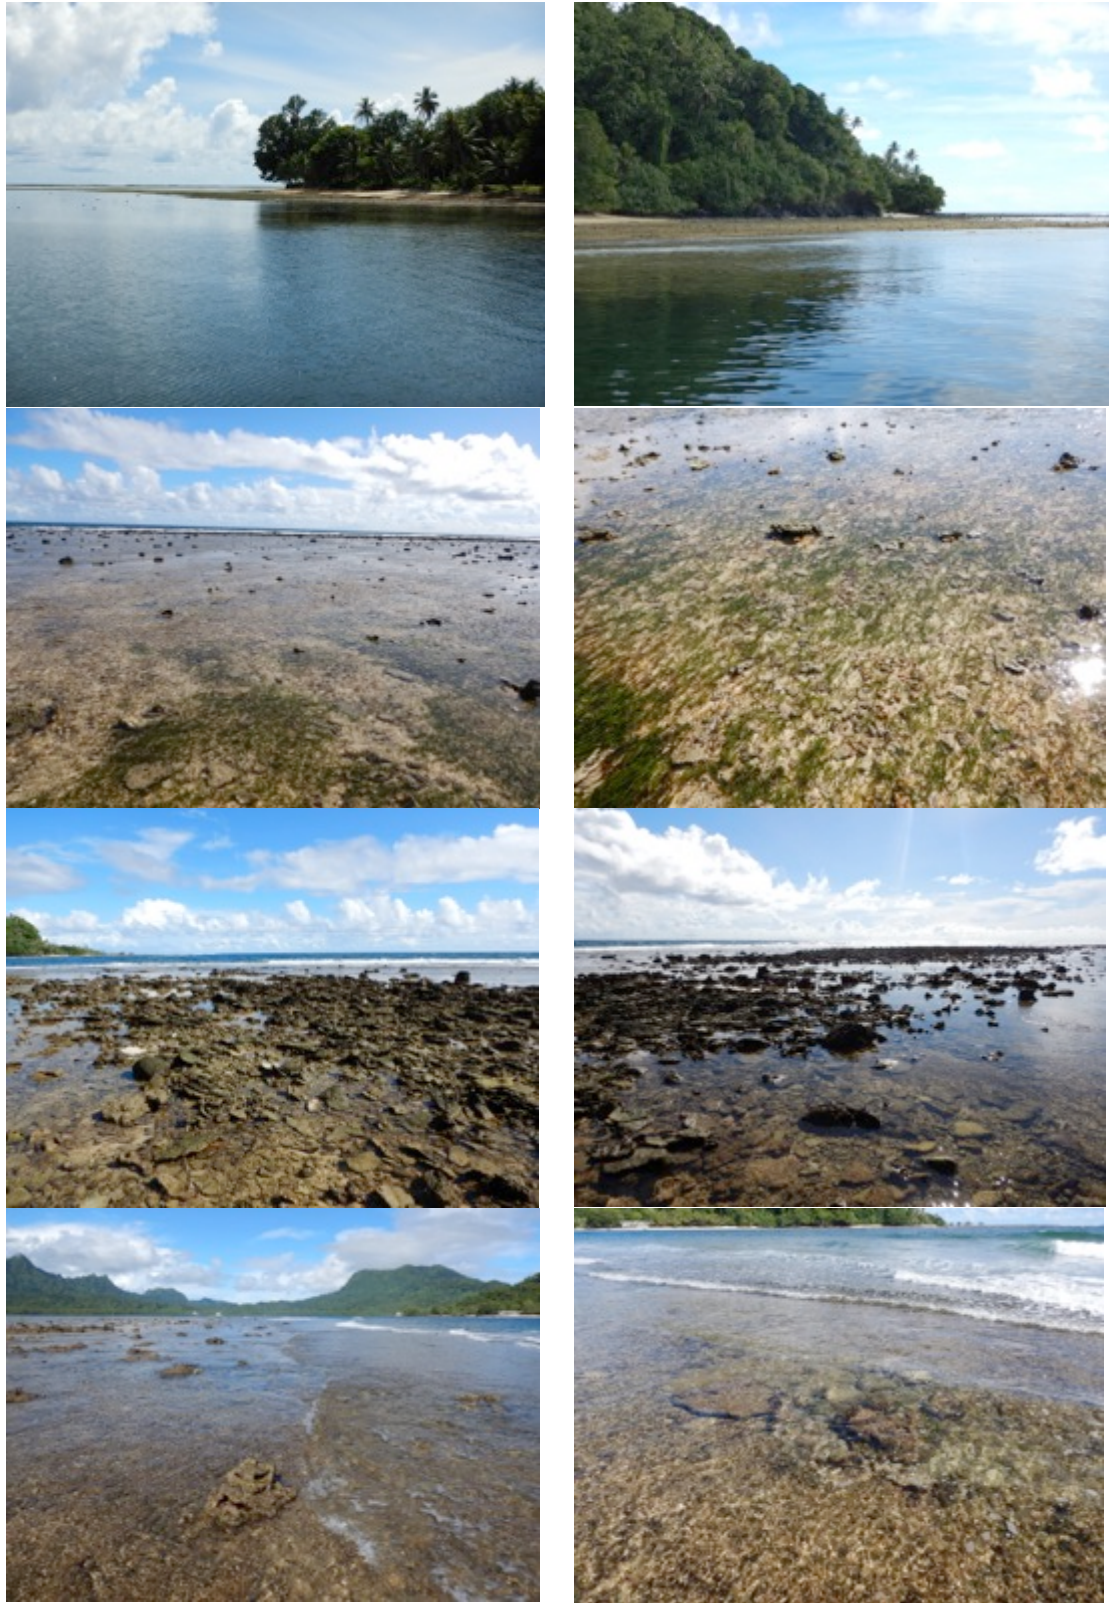
Figure 37: Representative photos of the different substrate types located on the intertidal reef flat systems adjacent to the submarine cable alignment within Lelu harbor and channel.

The reef flat is relatively flat throughout its entire area, however small vertical relief patches are found throughout both intertidal assessed areas which in general contain higher levels of sediment accumulation.

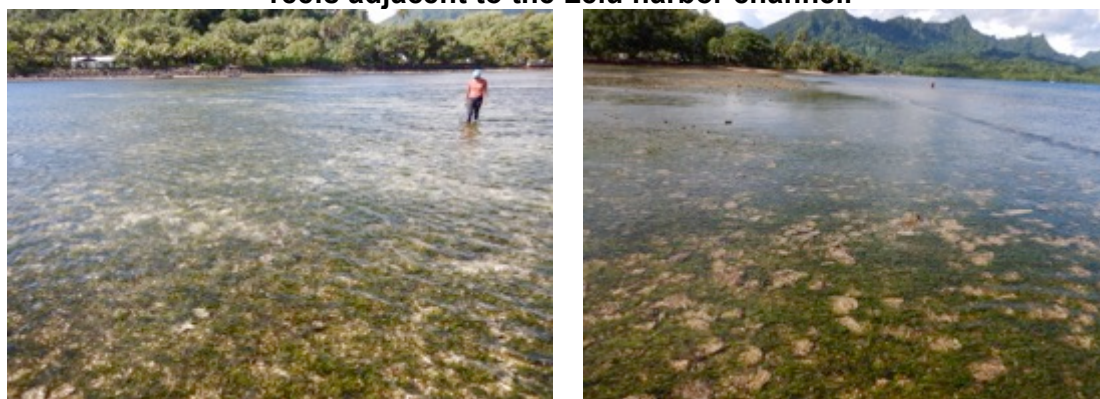
Figure 38: Representative photos of the marine resources located on the intertidal reef flat during the transect assessment of the northern and southern reefs adjacent to the Lelu harbor channel.

The inshore intertidal areas of both reef flats are dominated by healthy sea grass beds, dominated by two species *Enhalus acrorides* and *Thalassia hemprichii* which are more pronounced on the southern reef flat, especially the intertidal areas within the harbor itself in close proximity to the shoreline (Figure 38a). Similarly, the reef flat areas support healthy populations of several species of macroalgae (*Sargassum sp.*, *Padina Sp.*).

A significant amount of anthropogenic material and rubbish was located during the transect assessments with areas closer to the shoreline and harbor possessing higher percentage (Figure 38d).

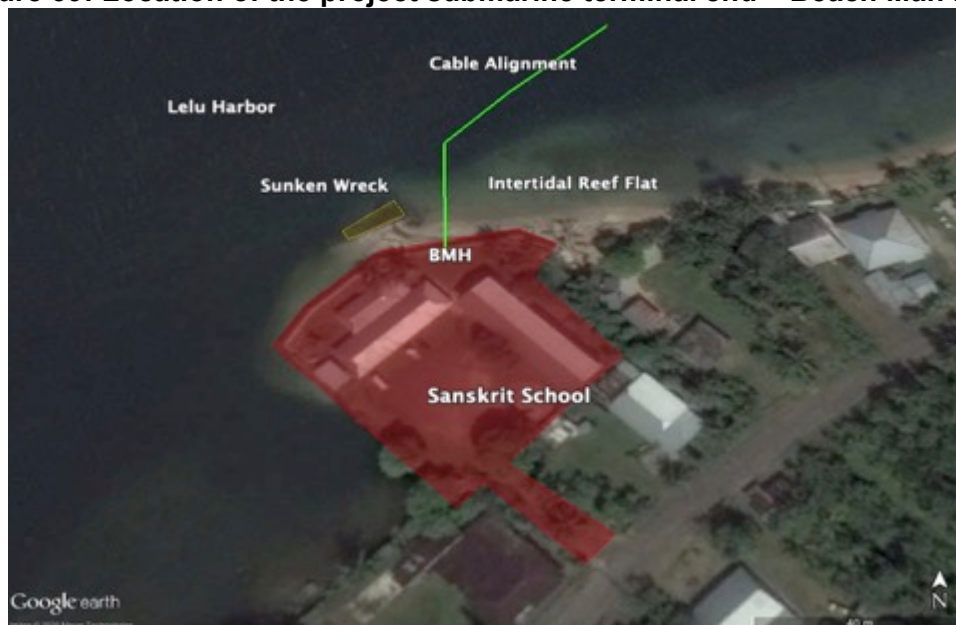
Figure 39: Location of the project submarine terminal end – Beach Man Hole.

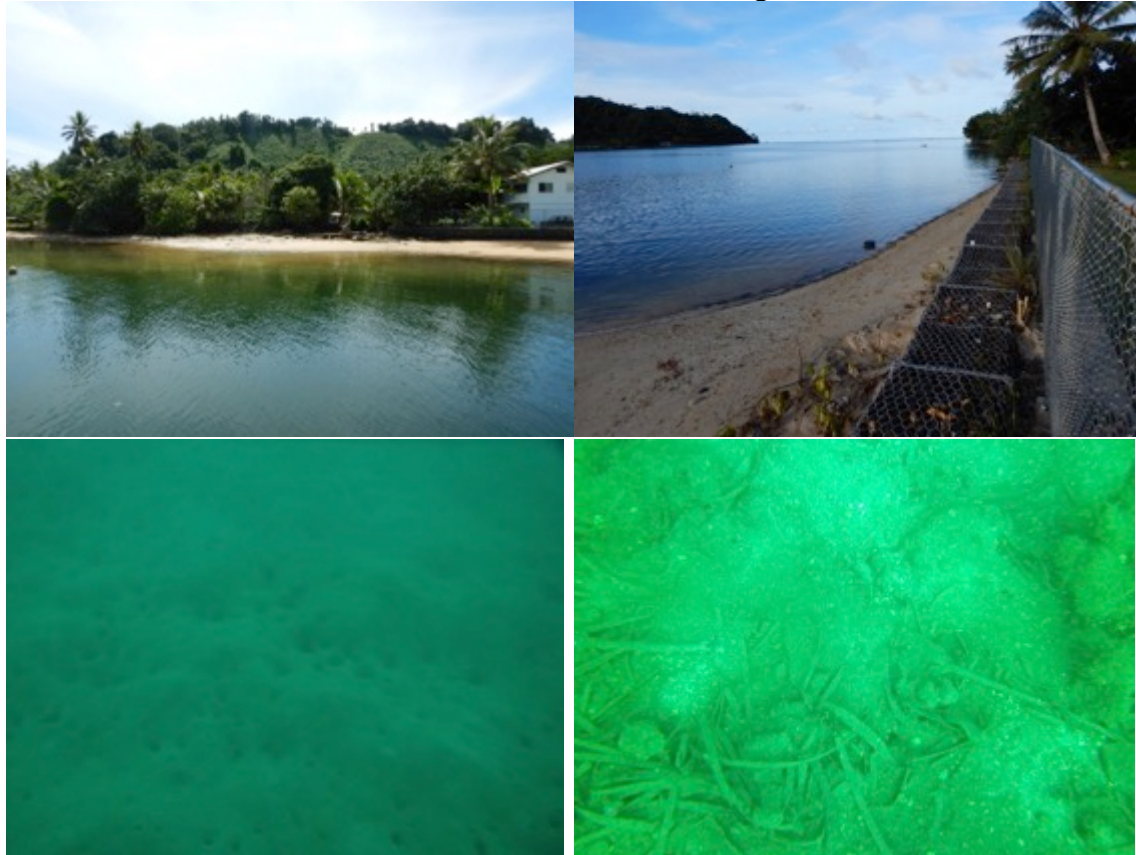
The submarine cable will enter the site (BMH) (Figure 40 a & b) directly from the southern side of Lelu harbor along the sea floor passing through both subtidal and intertidal benthic substrate zones.

There were no hard or soft coral colonies located directly adjacent to and opposite the proposed cable landing site. Macroalgae, predominately brown algae (*Sargassum* sp., *Padina* sp.) and to a much lesser extent colonies of calcium carbonate green colonies (*Halimeda* sp.), filamentous green and blue green algae were recorded in very low populations densities within the shallow intertidal reef areas to the east of the proposed landing site. Similarly, hard coral sub massive and massive colonies (*Porities* sp.) were recorded along the shoreline to the east (60 m) of the BMH, these hard coral colonies are expected to be well outside the area of influence of the project.

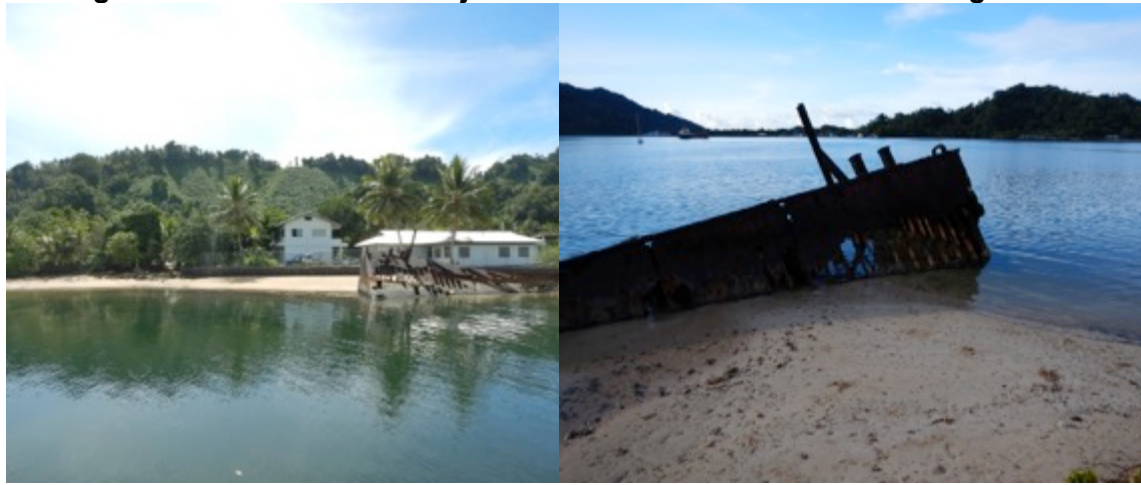
point (BMH) will be finalized in due course, however it is advise that due to the location of a sunken vessel directly in front of the land parcel consideration for the cable to enter east of this vessel is recommended.
